**Substantiation Testing on Automotive Impressed Current
Protection (ICP) Corrosion Protection System**

Test Report ITS – 18298.00 Rev. 2

REPORT DATE: 2/8/2019	ITS PROJECT NO: 18298.00
CUSTOMER: Warren Camp	CUSTOMER P.O.: N/A
COMPANY: The Auto Saver System, Inc.	CUSTOMER JOB NO: N/A
ADDRESS: 14 Jupiter Lane, Suite 2 Colonie, NY 12205	SPECIMEN SOURCE: Customer
PHONE NO: (800) 072-8155	TEST STAND NO: N/A
	FAX NO: N/A

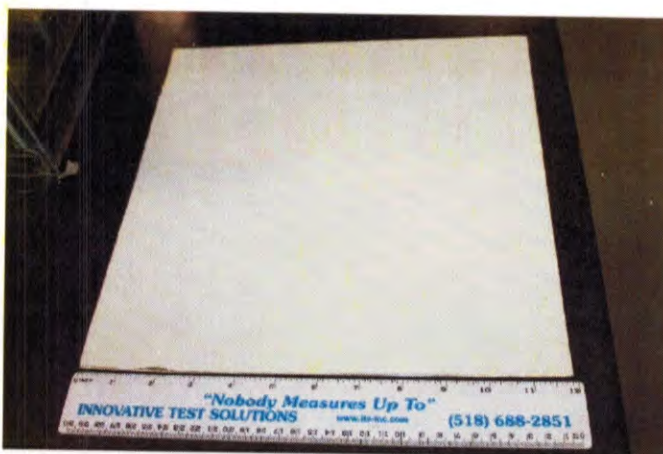
Figure 1: The Sectioned 1-foot X 1-foot test panel cut from the painted 36" X 48" panel.

For the test a 1-foot square test panel was cut from the painted 36" X 48" Galvanized Steel Sheet.

An eight (8) inch long scribe mark was made at a distance of 2.5 inches from the bottom of the panel and centered between the sides. The scribe depth was sufficient to pierce the paint layers and expose the bare metal substrate

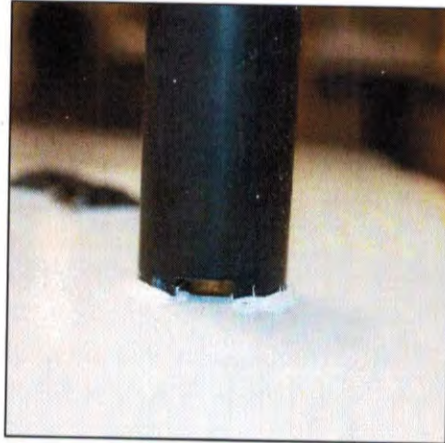
Figure 2: The plastic standoff adhered to the test panel.

The plastic standoff for the Luggin Capillary with Silver/Silver-Chloride reference electrode was adhered to the panel and straddled the scribe mark at center span. The standoff set the distance from the reference electrode to the panel surface at 0.005 inches. The panel was then placed in a circulating bath of 5% Sodium Chloride Salt Solution.

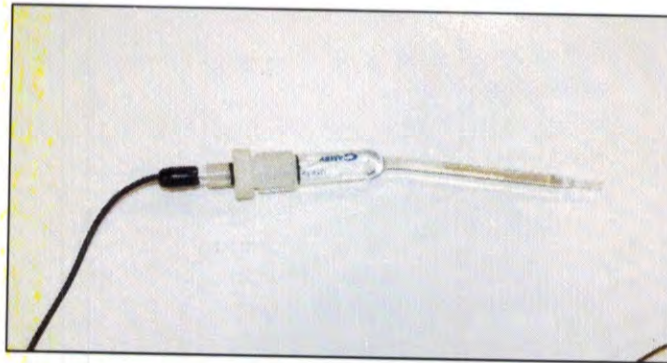
Figure 3: The Silver/Silver-Chloride Reference Electrode inserted into the Luggin Capillary.

The Reference Electrode was then inserted into the Luggin Capillary and the pair was positioned into the plastic standoff leaving approximately 0.005 inches of distance between the scribe mark and the Luggin Capillary.

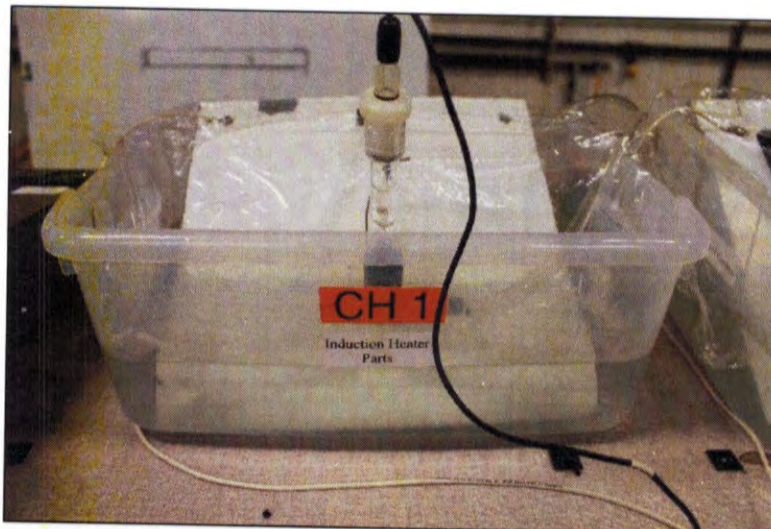
Figure 4: Electrically connected test panel with reference electrode attached shown with scribe mark submerged in 5% sodium-chloride salt solution.

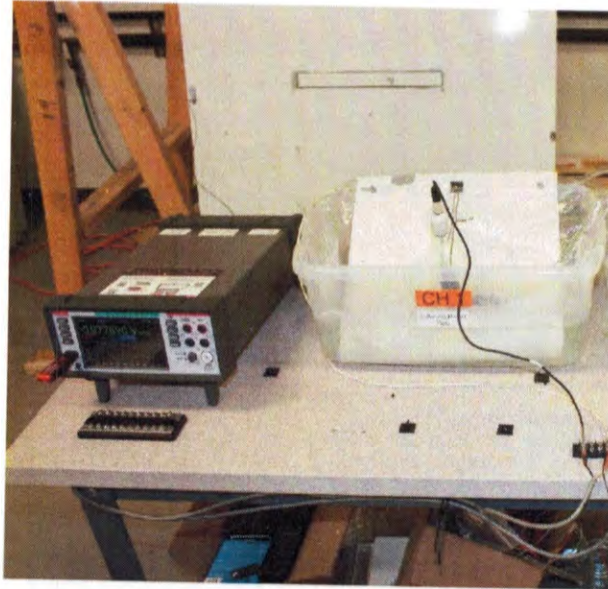
Figure 6: Test Set-up with data recorder

The test set-up was left in a temperature-controlled environment where the temperature was maintained at 72F +/- 5F for the duration of the test. The 5% Salt Solution was continuously circulated in the bath with the panel submerged to a point above the scribe mark. Plastic film was placed over the plastic tub to prevent evaporation of the solution.

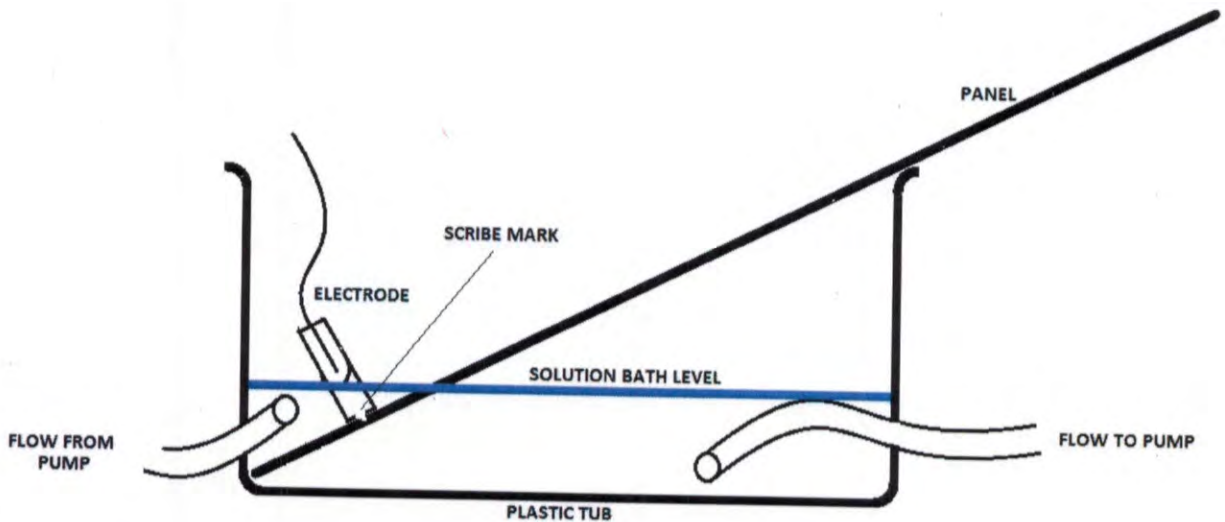
Figure 7: Diagram of panel position within bath of 5% Sodium Chloride solution

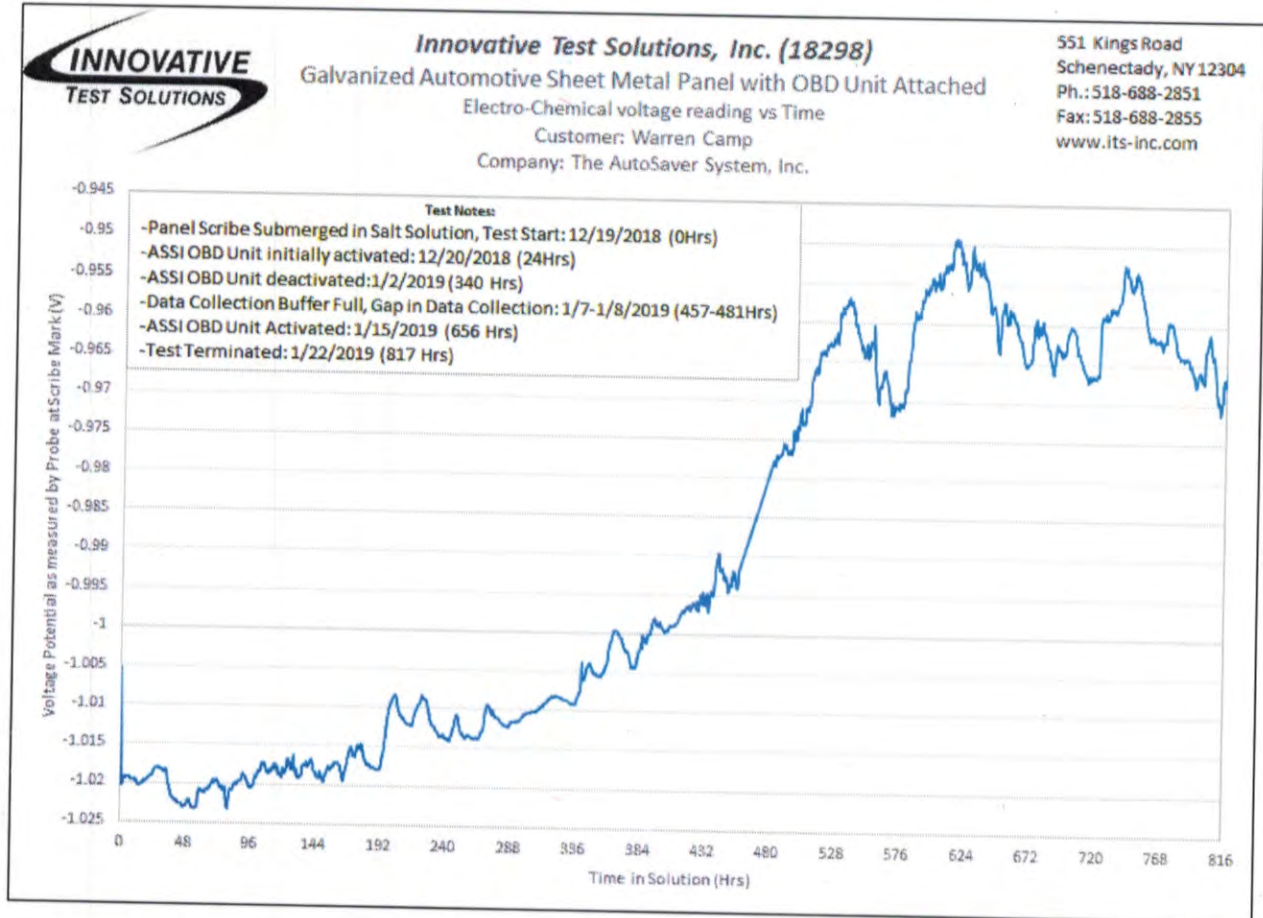
Figure 8: Graph of voltage as measured by the reference electrode vs time panel is submerged in solution.

Test notes box shows hour mark for specific events.

The reference electrode measured a potential of -1.02 V at the start of the test. The Auto Saver System, Inc. ICP device was activated after an initial 24 hour period of time and the reference electrode showed a shift of 0.01 V less negative ending at a measurement of potential of -1.008 V at the end of 316 hours of an active ICP device. Voltage from the DC power supply was 12.6 V DC and a current of 24.8 mA was measured over the distance from module to the scribe mark.

During the 316 subsequent hours when the ICP device was deactivated, the reference electrode measured a potential shift from a starting voltage of -1.008 V and ending at -0.959 V with greater fluctuation in voltage potential than what was recorded during the IPC device active period that preceded. The highest differential was at 616 hours when the potential was measured at -0.949 V.

The final test period when the ICP device was again initiated the shifting voltage potential reversed trend and was measured at -0.964 V at time of test termination.

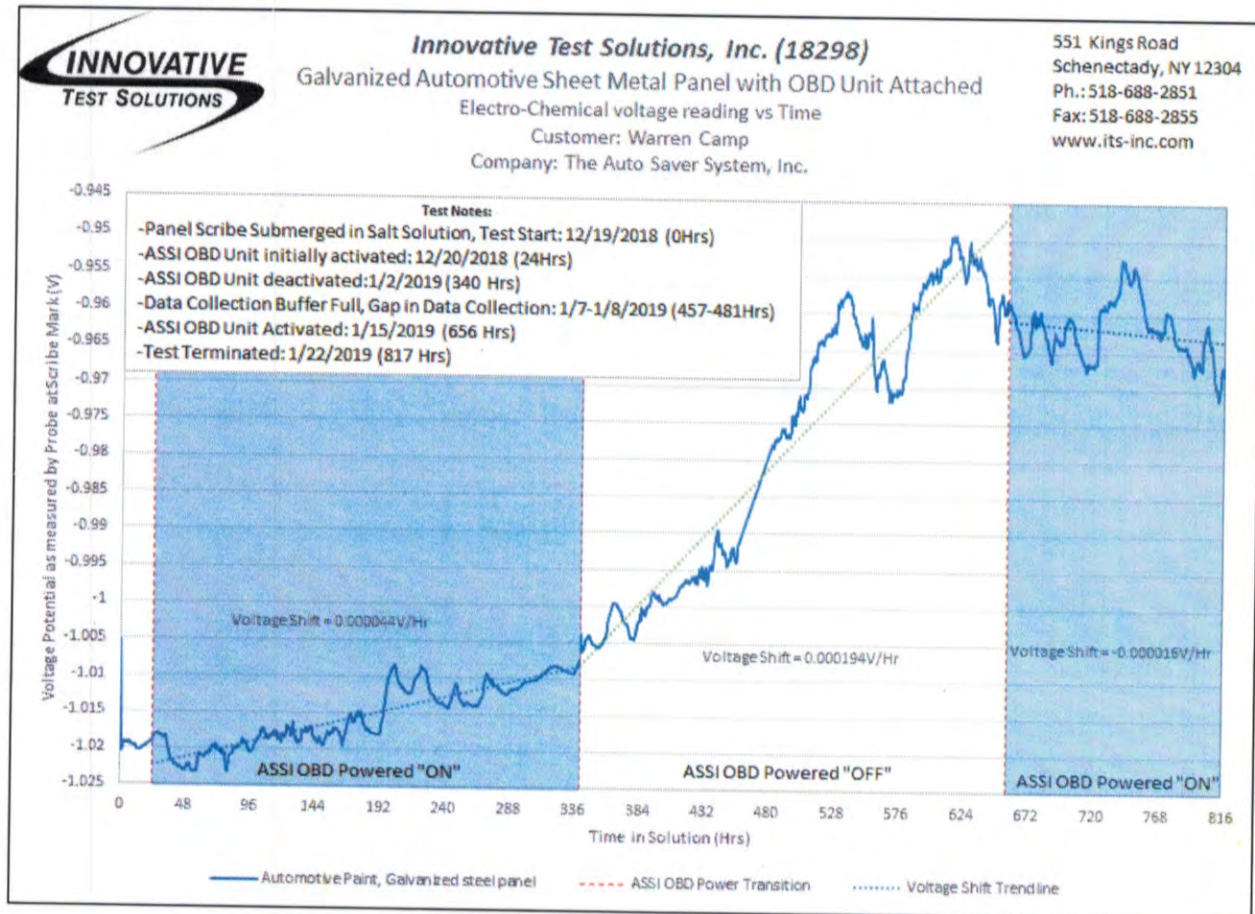
Figure 9: Same graph as previous page with sections of ICP device enabled highlighted in blue and voltage trendlines added for each section.

The Auto Saver System, Inc. ICP device showed an ability to suppress the voltage potential shift that was seen during the period when the ICP device was disabled.

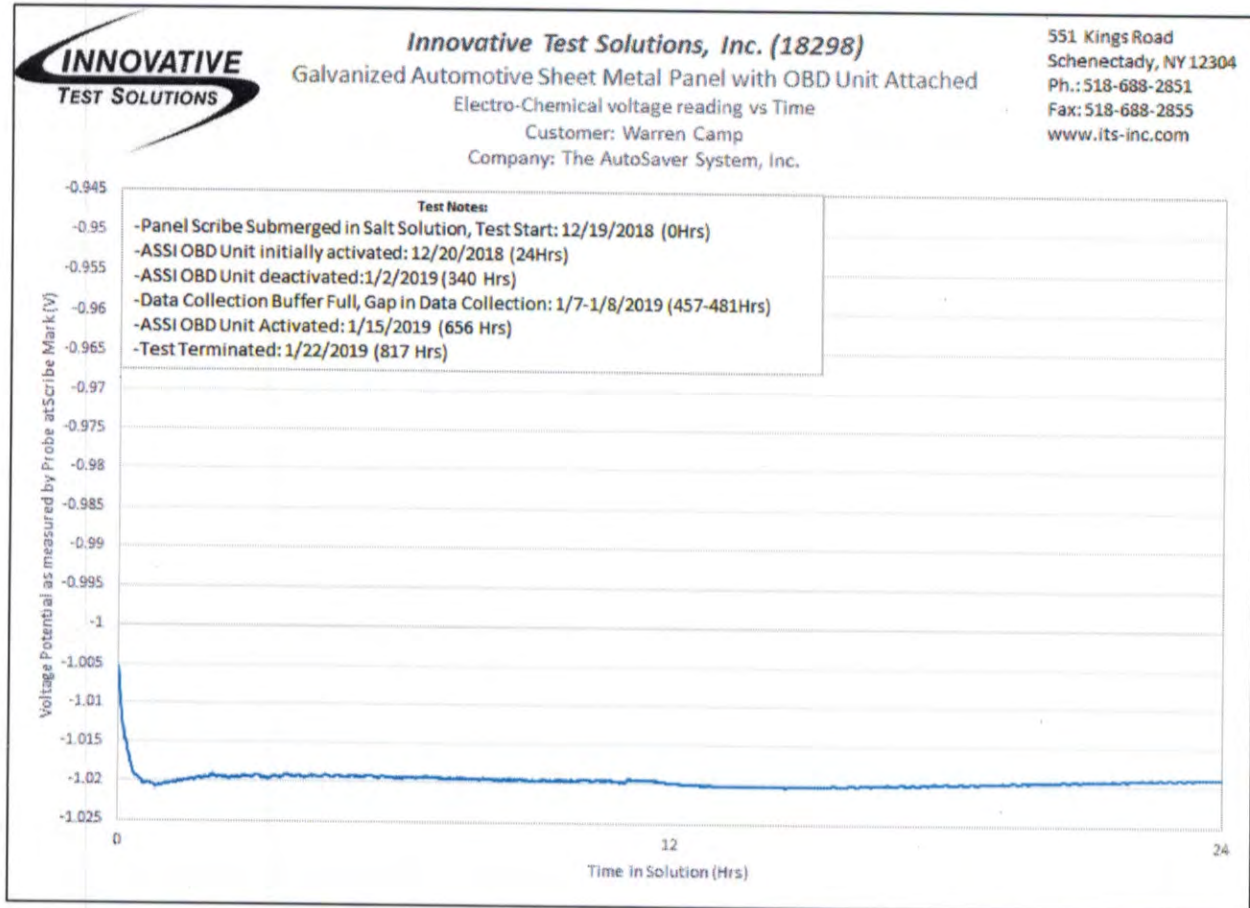
Figure 10: Graph of voltage vs time for initial 24 hour period of solution immersion and ICP device disabled.

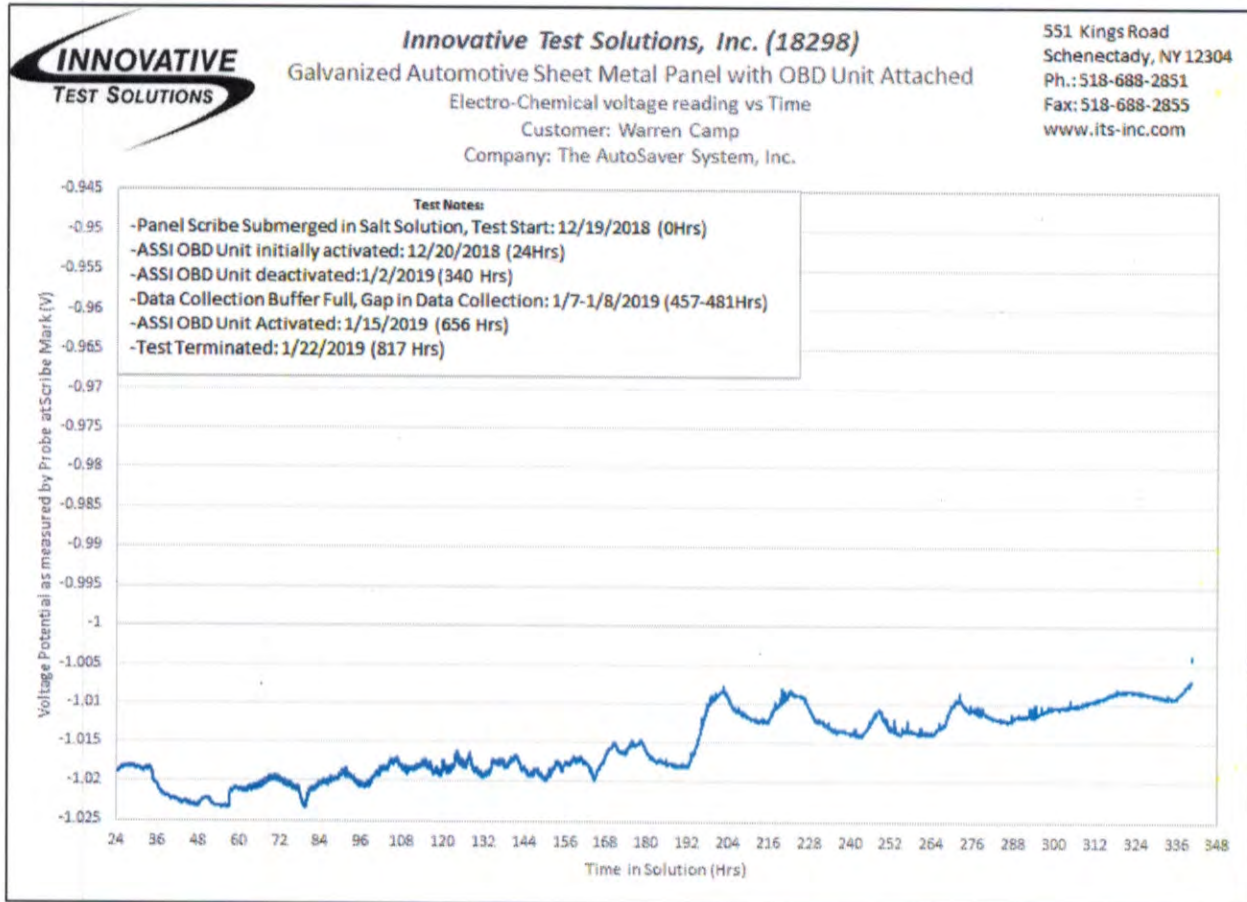
Figure 11: Graph of voltage vs time for initial period when ICP device activated.

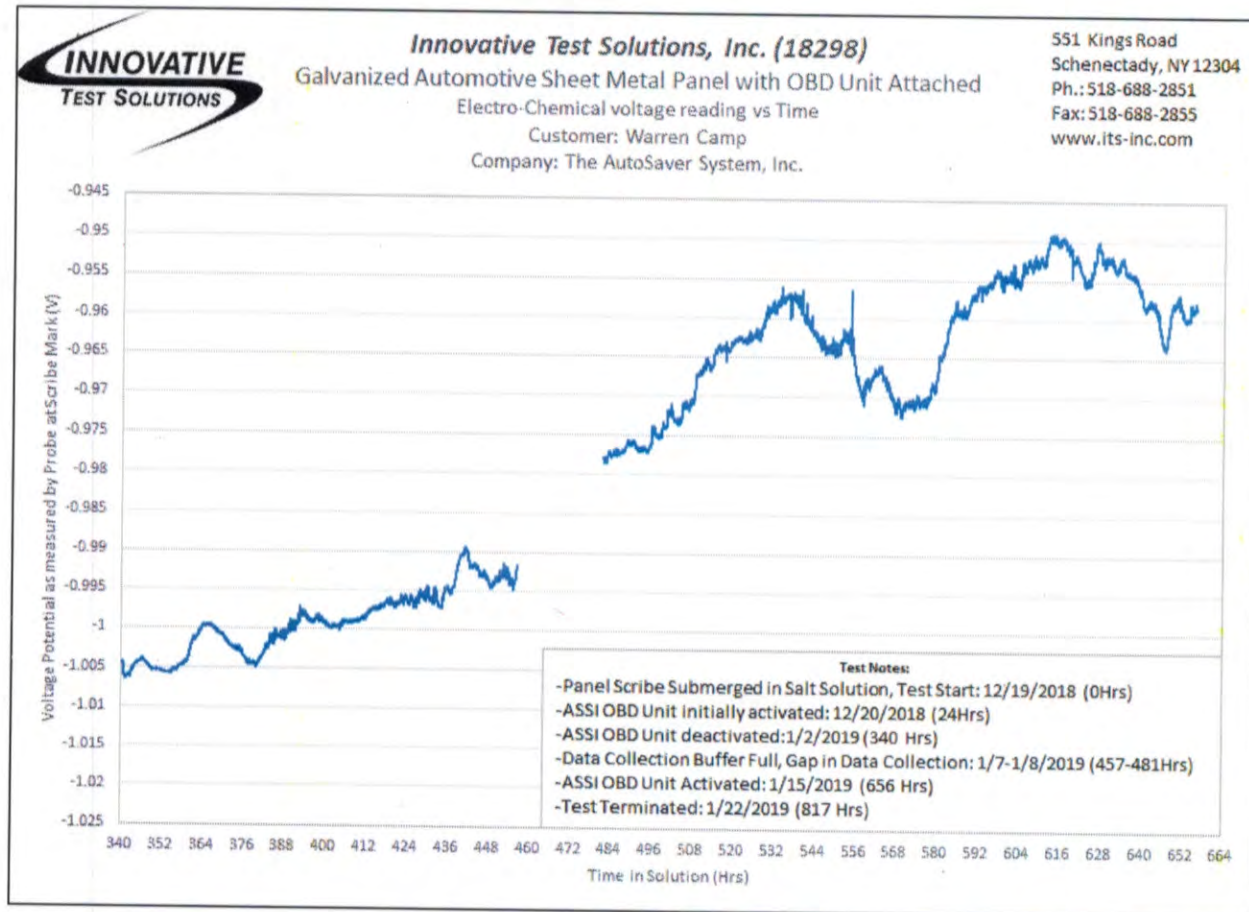
Figure 12: Graph of voltage vs time for the 316 hr period when ICP device disabled following initial ICP device activated period. Note that from 1/7/2019 to 1/8/2019 no voltage readings were collected.

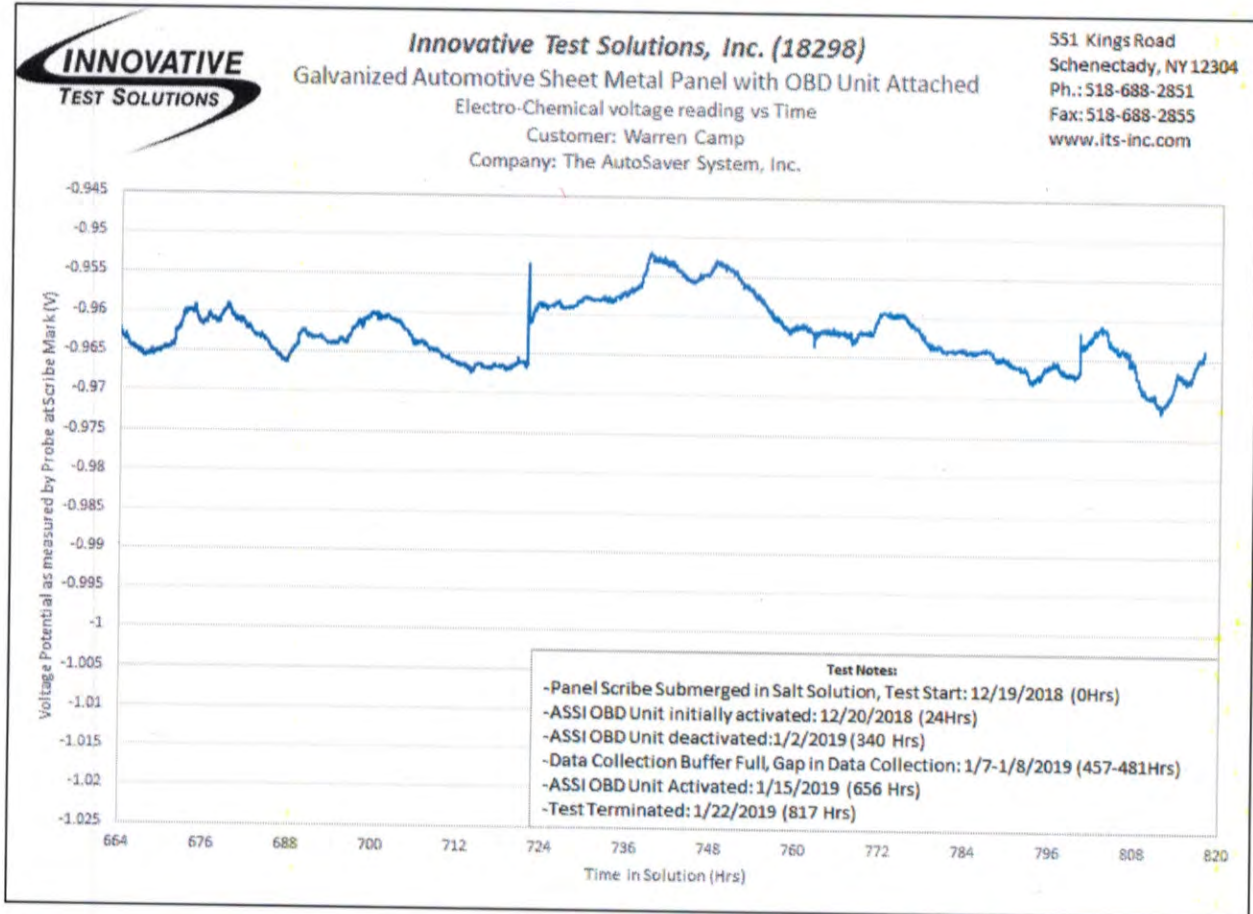
Figure 13: Graph of voltage vs time for final period when ICP device activated. The test was terminated after this period.
